**PHASE I REPORT  
NATIONAL DAM INSPECTION PROGRAM**

**NAME OF DAM:** Elroy Face Dam  
**STATE LOCATED:** Pennsylvania  
**COUNTY LOCATED:** Indiana  
**STREAM:** An Unnamed Tributary of Yellow Creek  
**SIZE CLASSIFICATION:** Small  
**HAZARD CLASSIFICATION:** Significant  
**OWNER:** Eastern Orthodox Foundation  
**DATE OF INSPECTION:** November 28 and December 12, 1979

ELROY FACE DAM  
NDI I.D. PA-281  
NOVEMBER 28, 1979

PHASE I REPORT  
NATIONAL DAM INSPECTION PROGRAM  
ELROY FACE DAM  
NDI I.D. PA-281  
DER I.D. 32-56

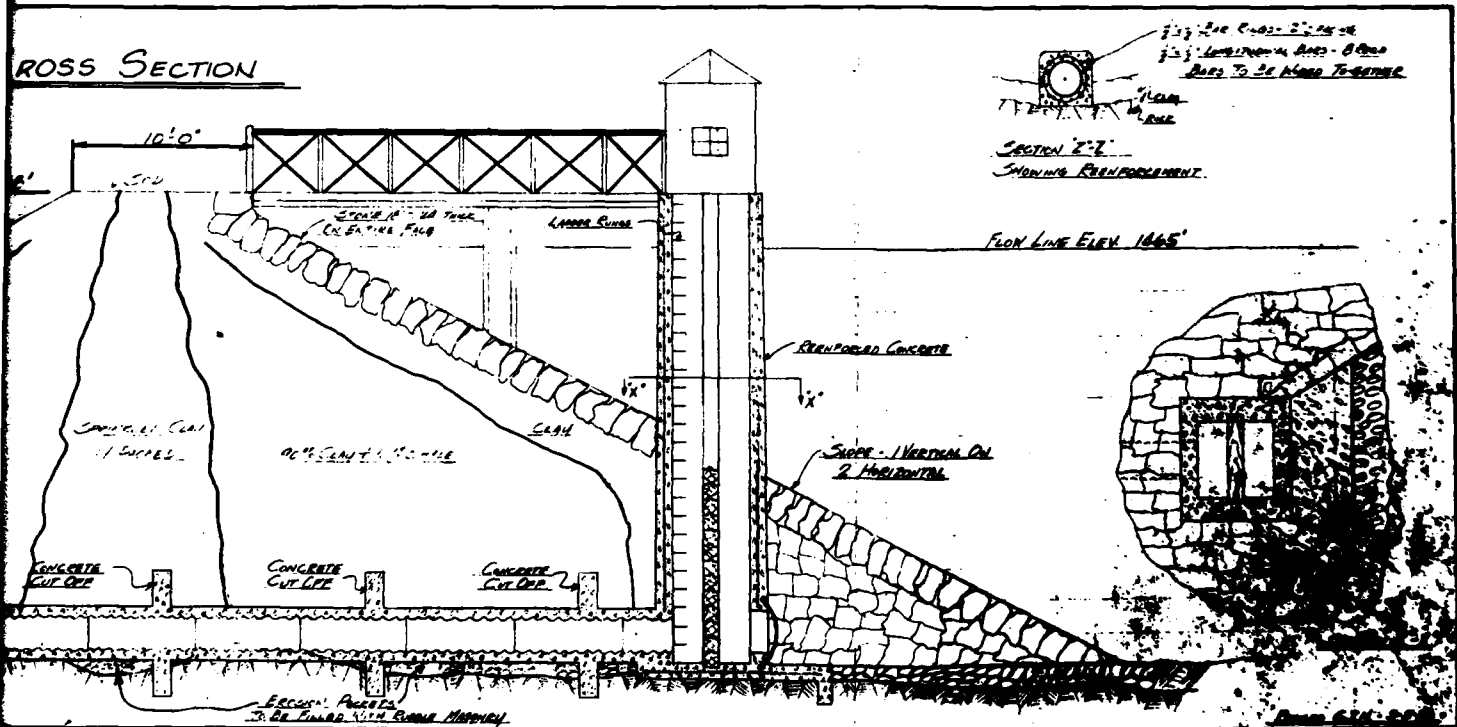
# ROSS SECTION

PROPOSED DAM : NOT FULLY IN  
CONFORMANCE WITH AS BUILT  
CONFIGURATION.

ELEVATIONS APPEAR TO BE RELATIVE  
TO A SITE DATUM NOT IN CONFORMANCE  
WITH U.S.G.S. ELEVATIONS.

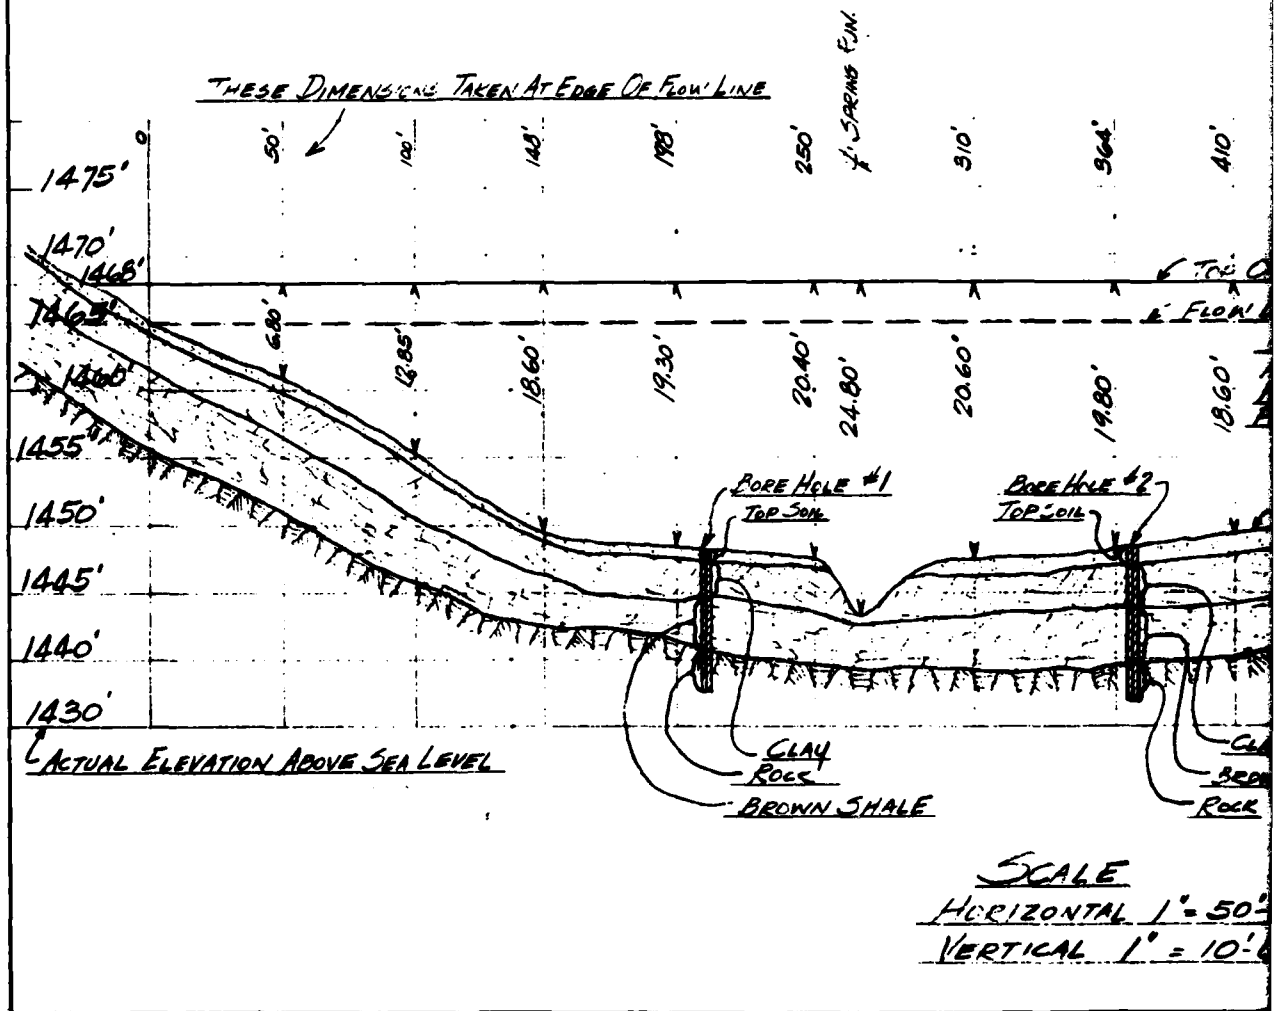
LONGITUDINAL SECTION - PROPOSED  
AT PIRES PEAK PA - CHERRY HILL TR  
INDIANA CO.  
G.J. HORAK NEW KENSINGTON, PA

1. PROPOSED DAM: NOT FULL CONFORMANCE WITH AS CONFIGURATION
2. ELEVATIONS APPEAR TO TO A SITE DATUM NOT IN WITH U.S.G.S. ELEVATIONS

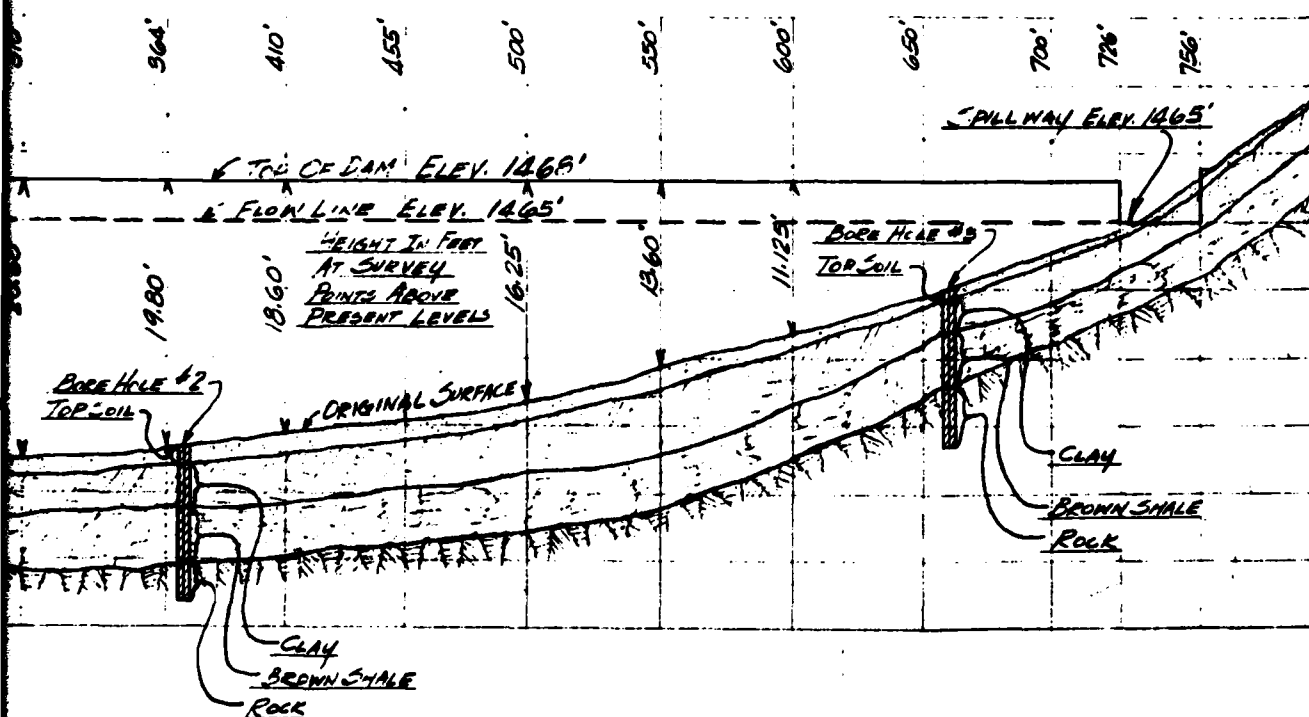
LOCATION - PROPOSED DAM  
 - CHERRY HILL TWP. -  
 Co.,  
 NEW KENSINGTON, PA.

DAM: NOT FULLY IN  
 RMANCE WITH AS BUILT  
 URATION

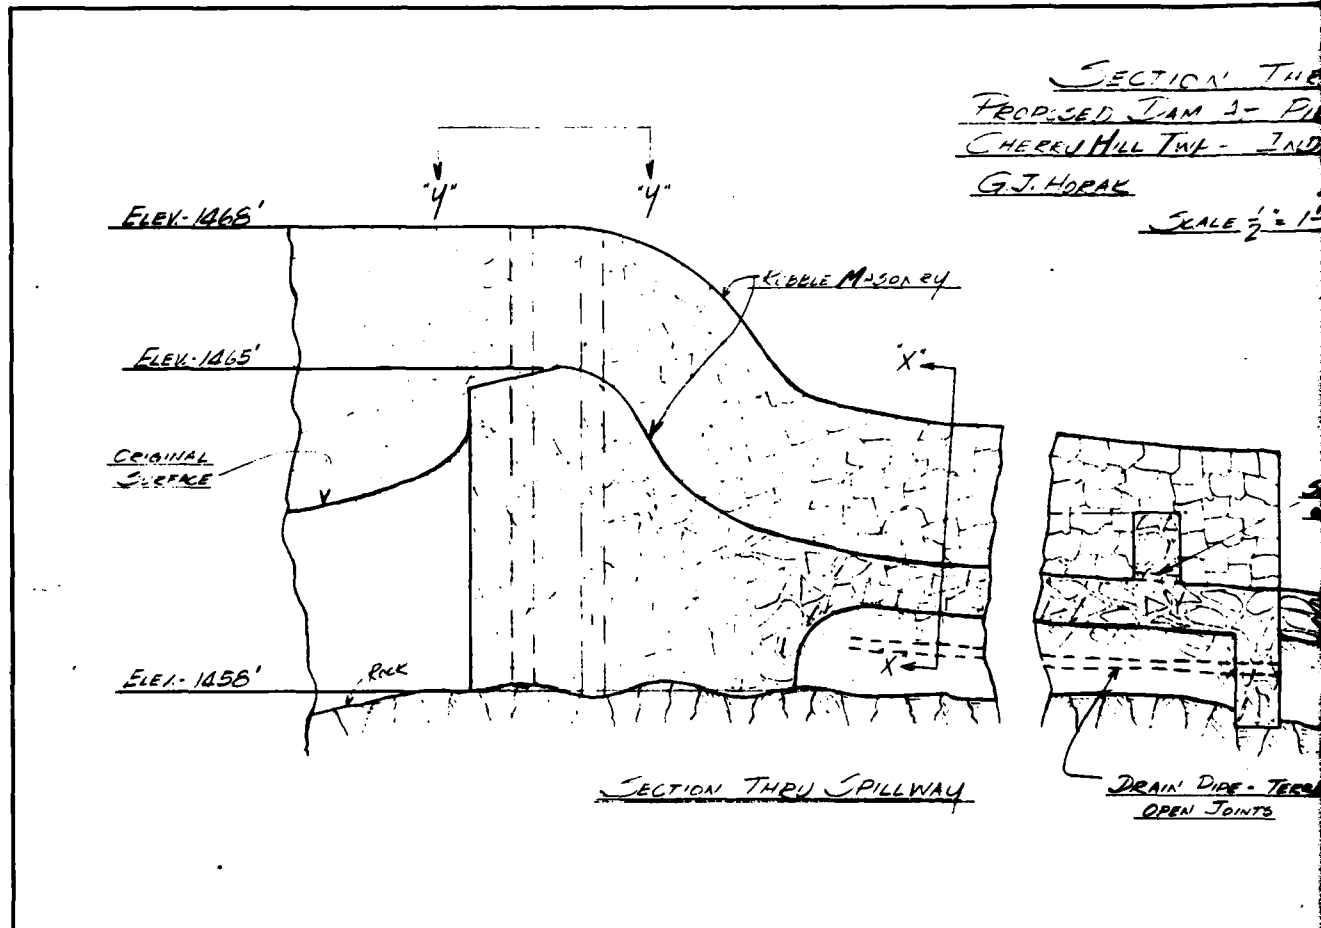
DRAWN BY	ACS	CHECKED BY	1/4/80	DRAWING NUMBER	79-543-B18
BY	1-2-80	APPROVED BY	1/4/80

1. PROPOSED DAM: NOT FULL CONFORMANCE WITH AS CONFIGURATION.
2. ELEVATIONS APPEAR TO TO A SITE DATUM NOT WITH U.S.G.S. ELEVATION
